Experimental observations of damage propagation in open hole tension specimens

A Study of Damage Initiation and Growth in Composite Bolted Joints

Deliverable No: D3.3

Experimental Observations of Damage Propagation in Open Hole Tension Specimens

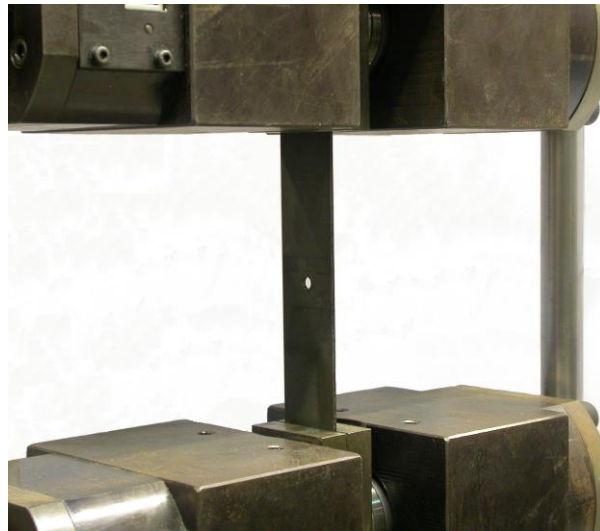
Figure 2 Open hole tension specimen clamped in the straining frame grips

All open hole tension testing was performed at 0.03mm/s (approximately 2mm/min) on a 100kN Zwick/Roell universal straining frame. Grips on this machine were hydraulically operated and all grips had dedicated composite gripping faces. The grip area dimensions on the straining frame were nominally 75mm by 50 mm. Grip pressures of between 150 – 200 bar were applied to the specimens during loading to prevent slippage within the grips. Figure 2 shows a typical test set-up with a HTA 6376 CFRP open hole tension specimen clamped in the strain frame grips.

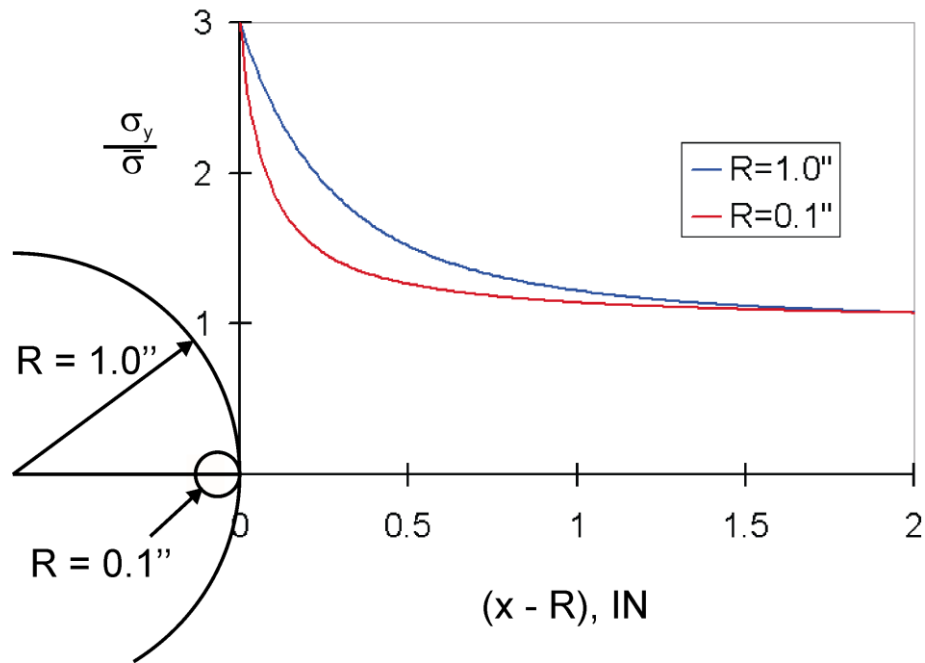
Figure 17 Stress distribution for a hole in an infinite plate (Whitney and Nuismer [9])

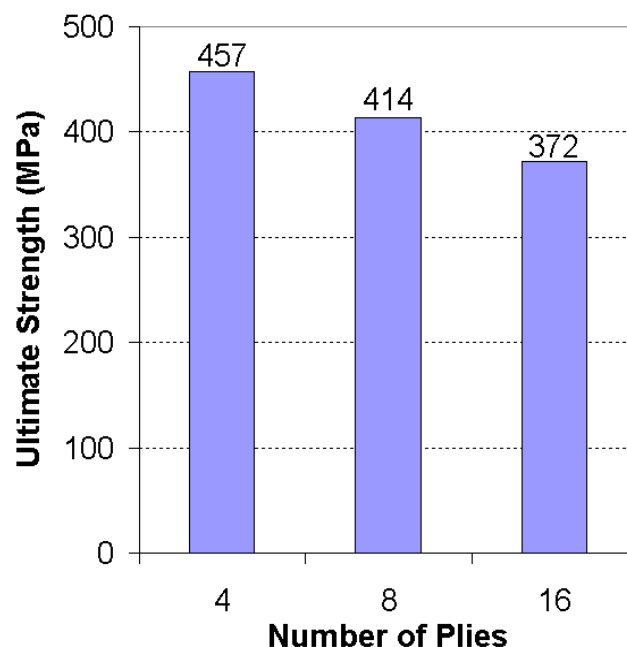
Figure 19 Change in the ultimate strength of S2 FM94 GFRP cross-ply open hole tension specimens with increasing thickness

The effect of thickness on damage initiation and growth can be best seen by examining the cross-ply open hole laminates, CP₁, CP₂ and CP₃. All of these laminates have the same type of alternating stacking sequence. As no CP₂ laminate was examined for the HTA 6376 CFRP material the discussion is limited to the S2 FM94 material system, however, CP₁ and CP₃ laminates tested in both material systems showed very similar damage characteristics for each laminate type. Looking at the backlight images of the three different laminate types (figures 13 – 15) it is clear that all laminates exhibit typical damage characteristics of cross-ply laminates, however, the extent of damage prior to ultimate failure, in the form of matrix cracks in the zero degree plies, increases with decreasing thickness. This suggests that more notch blunting occurs in thinner laminates, which decreases the stress concentration due to the hole in the laminate. Examination of the open hole tensile strengths for each of these laminates, shown in figure 19, shows that strength decreases with increasing thickness indicating that additional notch blunting in thinner laminates helps to increase the laminate open hole tensile strength.
